LS-TB-016

PC PUMP CORROSION RESISTANT COATINGS

OCT 6 2020

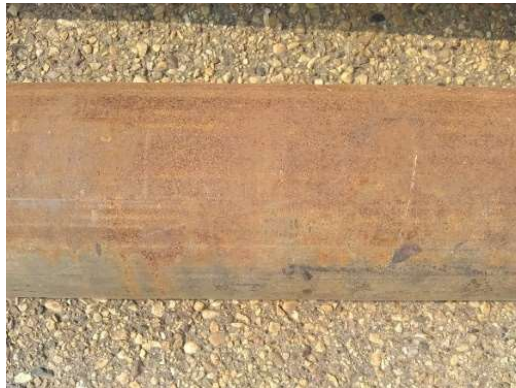
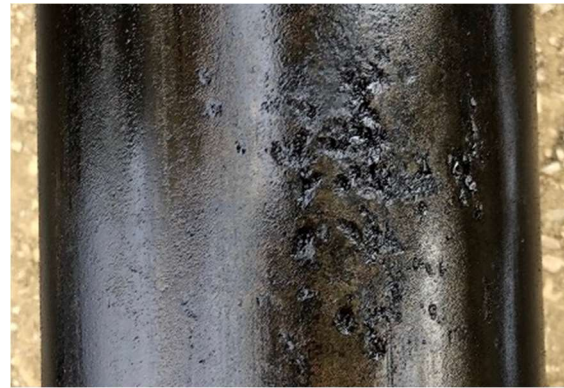
Within the Canadian market most progressing cavity (PC) pump stators are no longer painted as the historical paint only served a cosmetic purpose and was as such was a non-added value cost in a cost sensitive market. The result is that the typically carbon steel stator tubes experience corrosion when stored outside or after exposure to the downhole well environment. Normally this corrosion is limited to the surface such as shown in Figure 1a and has no impact on pump functionality given that the stator tube is usually is not subject to high loads and serves primarily as a housing for the elastomer and attachment to the tubing and other accessories. However, there are downhole environments where the tube corrosion can become more aggressive such as shown in Figure 1b where it has resulted in pits and associated loss of tube material. If severe enough the structural integrity of the stator body or end connections can be compromised potentially leading to failures.

Figure 1 Stator Tube Corrosion – (a) normal surface corrosion; (b) structural corrosion.

Corrosion inhibition can be effective at minimizing stator tube corrosion provided that the treatment can contact the stator surface but this is often not a preferred solution due to treatment logistics and cost.
