CASE STUDY

COATED ENDLESS ROD CER10K | CS-003

CLIENT NAME | Cardinal Energy

LS PRODUCT | 1" Grade ND Coated Endless Rod

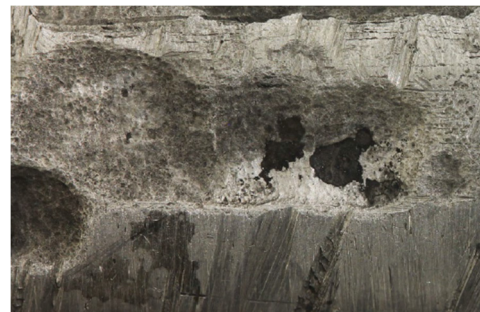
Lifting Solutions conducted engineering level inspections on several rod string failures and determined that corrosion involving H_2S was contributing to localized pits resulting in the propagation of fatigue cracks from pits measuring as deep as 0.048".

Figure 2, Characterization of the corrosion pits, deepest measured pit approximately 0.048"

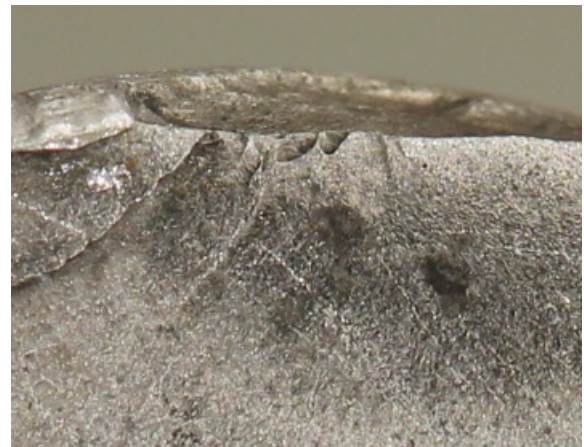
Figure 4, Closeup of the fatigue initiation point originating from the base of a corrosion pit

When sucker rods experience “pitting” from corrosion, it creates a concentrated point of fatigue that may not be able to withstand the torsional/axial loads the rod string experiences. The poly-coating on the outside of the coated rod string prevents the corrosive/abrasive fluid from initiating corrosion pitting. These pits are a stress riser on the external surface of the rod string creating a fatigue crack propagation point during cyclic bending and torsional fluctuation fatigue cycles.
