**125%
LONGER
RUNTIME.
ZERO ROD
FAILURES.**

Reducing Rod Failures in an RRP Application with KeBond™ Endless Rod®

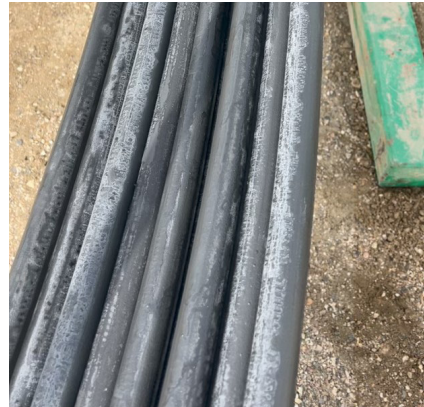
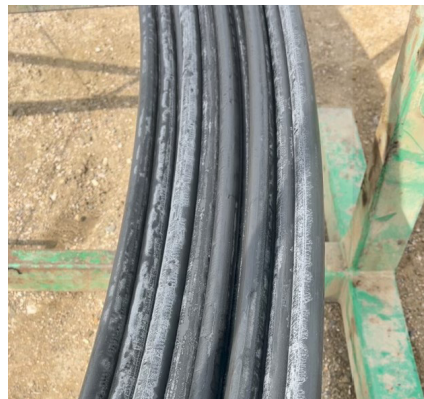
Surfaced KeBond after 174 days in operation (pulled due to tubing failure).

Since the change, the rod has operated for 583 days and counting with no rod failures. When it was later pulled and inspected because of a tubing failure, the KeBond coating showed no notable wear and remained fully intact.
