LS-TB-012 V1

PC PUMP ROTOR LANDING OVERVIEW

MARCH 9 2020

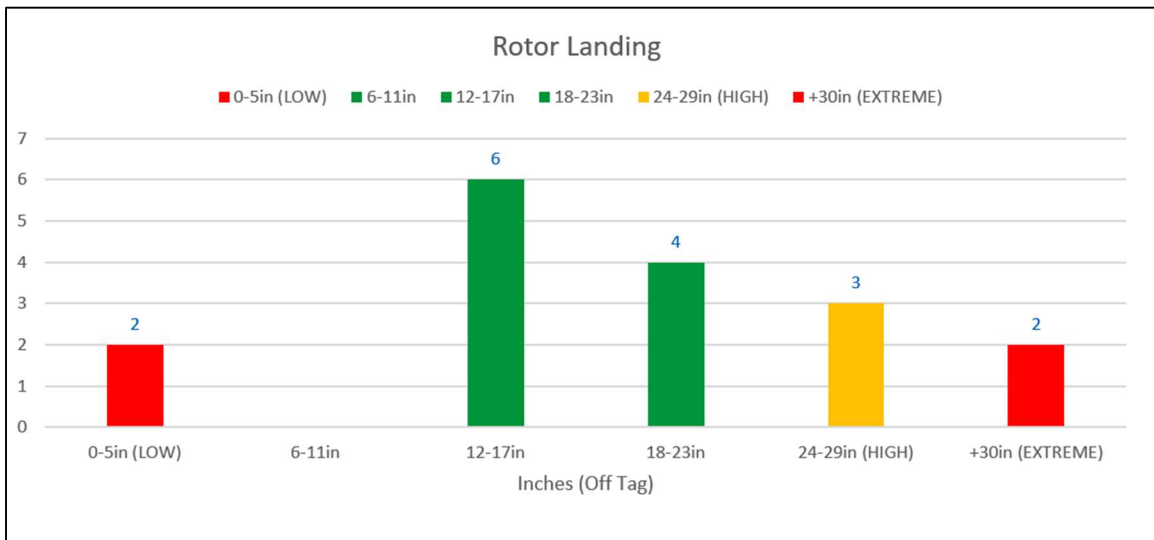
In addition, this feedback loop is typically shared in our quarterly pump review meetings. Below is a graphical snapshot based on the inspections performed.

The third step is a continuous feedback loop from the pump shop inspections that tells us how we are doing with these recommendations. If any adjustments are to be made, they are made to the above stated ideal distance off tagbar to bring things into better alignment with respect to space out.
